# M-37 and M-115 Wexford County Road Safety Audit

Michigan Department of Transportation

ROAD SAFETY AUDIT:

## M-37 and M-115 Wexford County

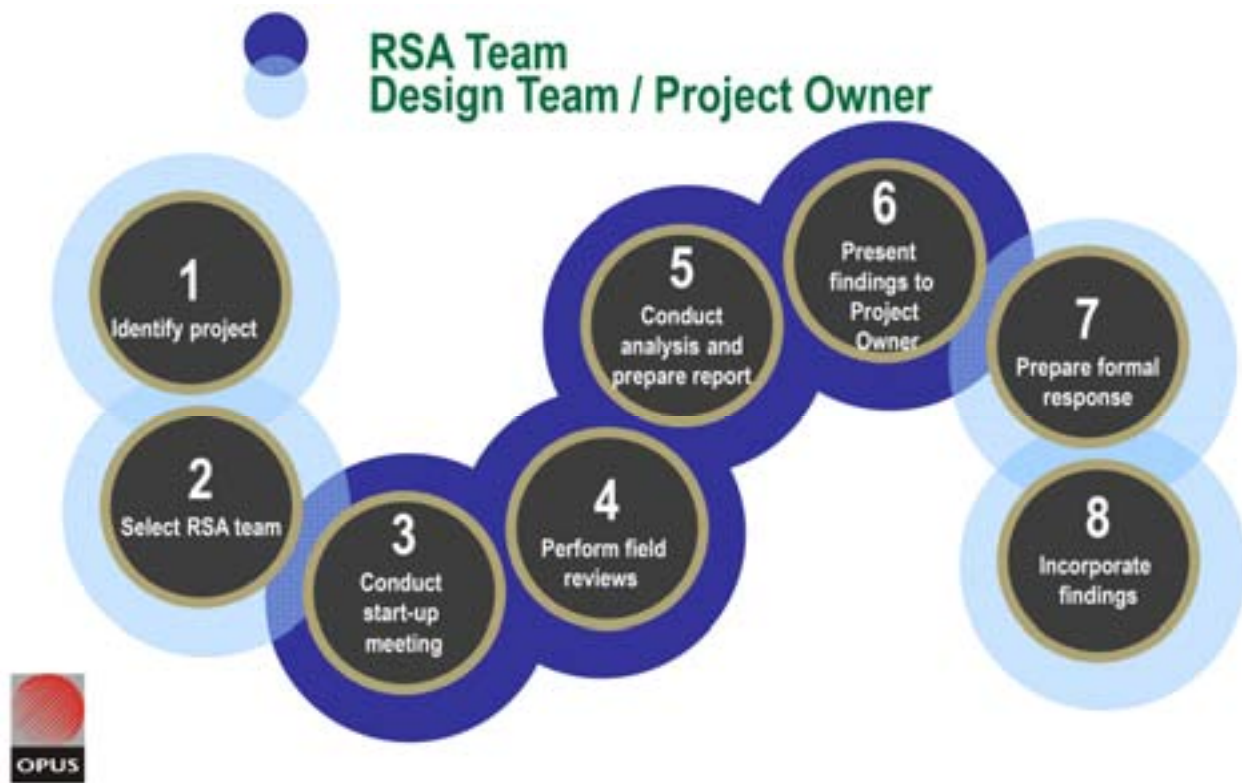
**Figure 1 - RSA 8 Step Process**

This RSA followed the eight-step process which is detailed in Figure 1 below.

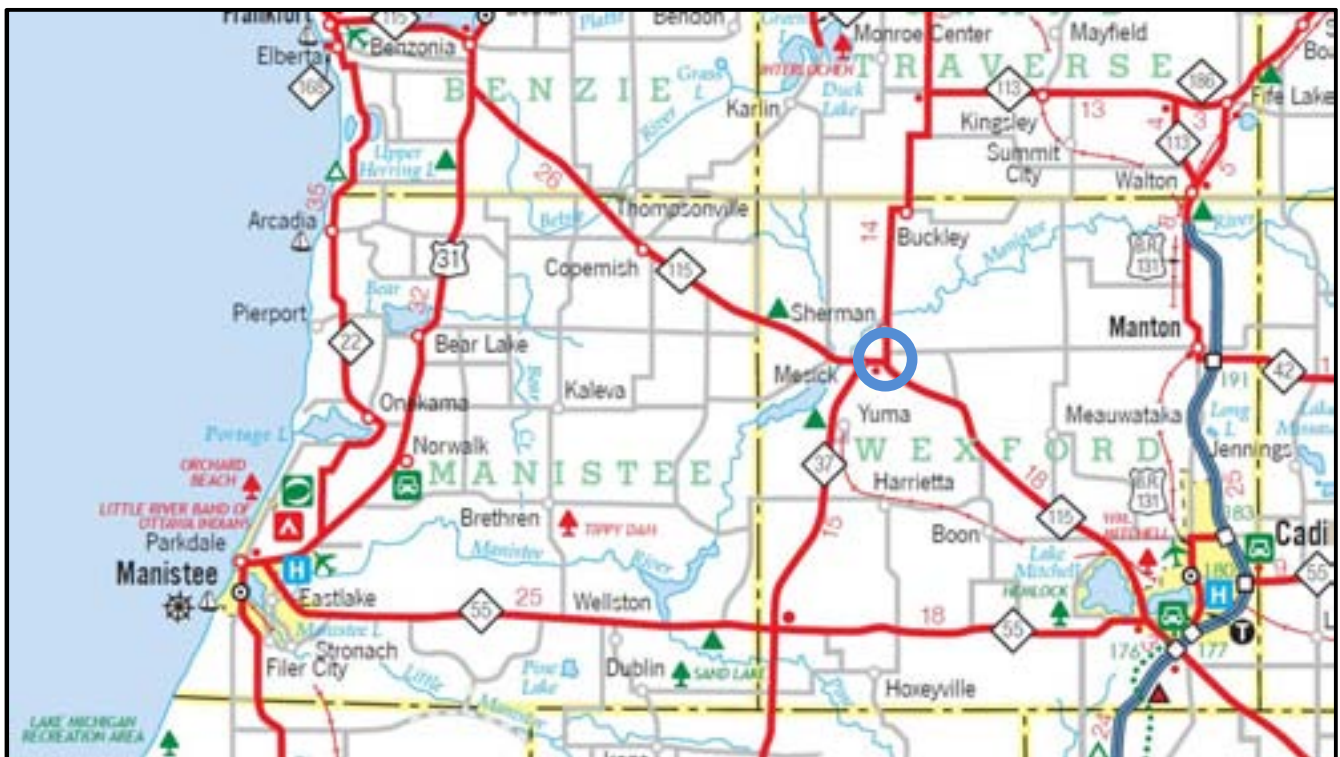
**Figure 2 - Study Intersection**

The intersection analyzed in this report is the eastern intersection of M-115 and M-37 is circled in blue in Figure 2. This intersection was chosen by MDOT for safety assessment on the basis of crash history.

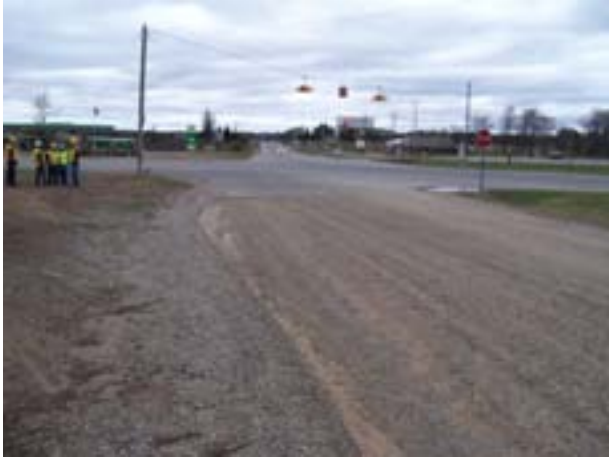
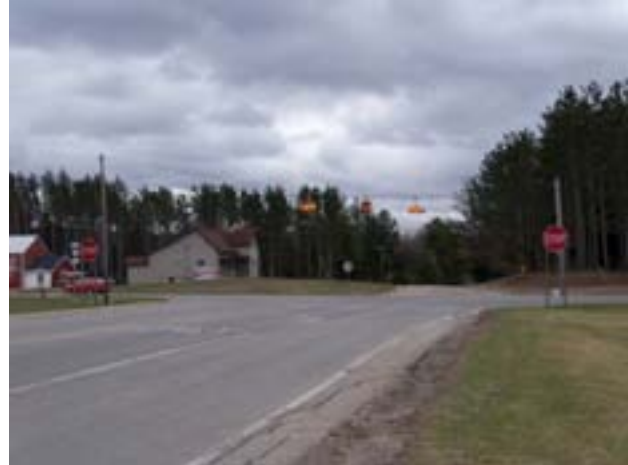
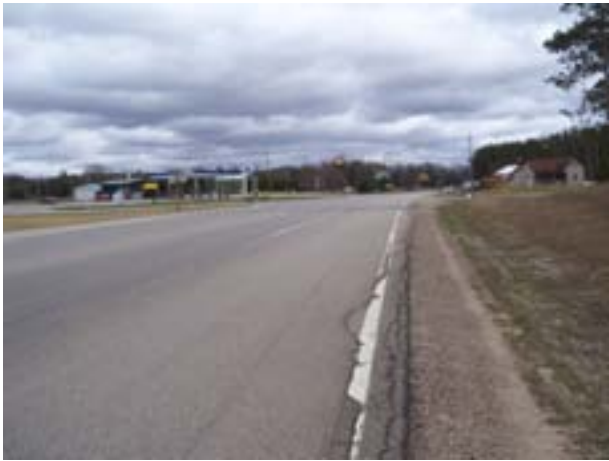
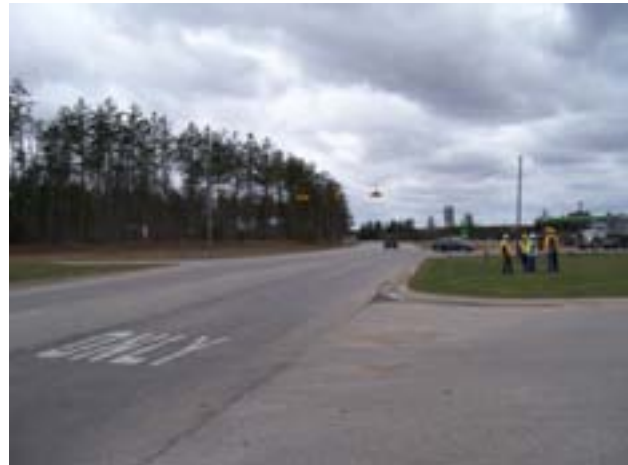
**Figure 4 - Site Photographs**

- The south leg is an unpaved road with an un-posted speed limit.
- The posted speed limit is 55 mph on the north, east and west leg.
- Passing flares exist on the eastbound approach.
- Pavement markings were observed to be in poor condition during the site visit.

*Northbound approach along M-37*

*Southbound approach along M-37*

*Eastbound approach along M-115*

*Westbound approach along M-115*

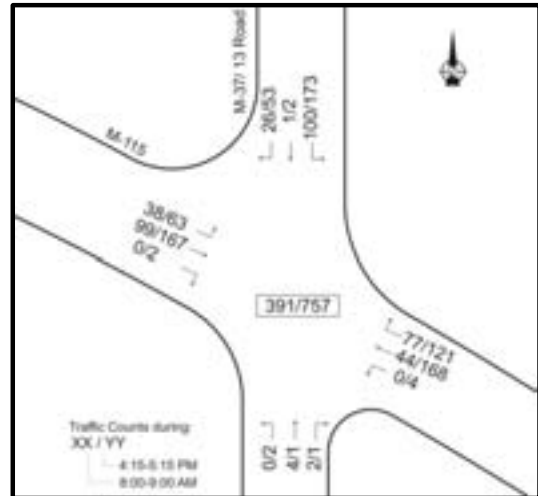
Figure 5 - Turning Movement Counts

Currently this intersection operates with one through lane on each approach. A dedicated left-turn lane is provided on the southbound approach and a dedicated right-turn lane is provided on the eastbound and westbound approaches. Annual average daily traffic (AADT) is 9,500 vehicles/day on M-115 (west of intersection) and 4,200 vehicles/day on M-37 (north of intersection). Turning movement counts for the AM and PM peak hour are summarized in Figure 5.

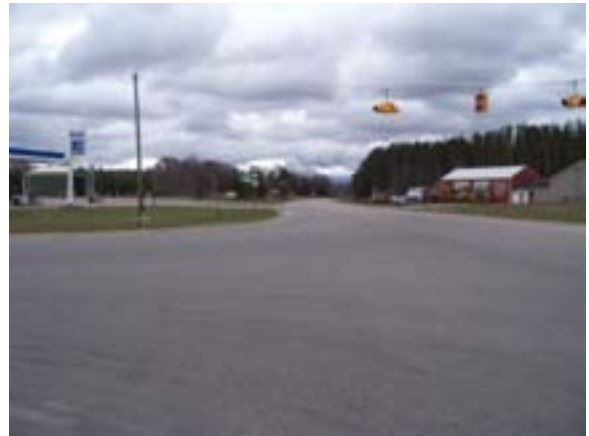
The majority of crashes at the intersection resulted in angle collisions. This trend may be due to various sight obstructions at the intersection. Temporary produce stands have been an issue in the past resulting in an obstruction on the southwest corner. Signs, warning of a civil infraction have been posted to prevent produce stands from being displayed in the right-of-way.

The majority of angle collisions involved a southbound traveling vehicle and a westbound traveling vehicle. This crash pattern is a result of the lack of an offset right-turn on the westbound approach. Drivers stopped on the southbound approach, may have limited sight distance due to westbound right turning vehicles, particularly large trucks that block vehicles traveling adjacent to them in the through lane. At least one fatal crash was a result of a truck turning right from the westbound approach obstructing the view between a motorcycle traveling adjacent to it and a southbound vehicle that chose an inadequate gap and was struck by the motorcycle.

**Expected Crash Types:** Angle  
**Expected Frequency:** Frequent  
**Expected Severity:** Extreme  
**Risk Rating:** F

### Suggestion 1: Roundabout Installation

Consider installing the proposed roundabout design. The installation of a roundabout would increase safety at this intersection by reducing conflict points and vehicle speeds. Roundabouts typically result in a reduction in crash frequency, especially for left-turn and angle crashes<sup>1</sup>. The majority of crashes that resulted in angle collisions due to sight obstructions would be eliminated. In addition to reducing conflict points, the installation of a roundabout would also reduce injury severity. Twenty-four percent of crashes resulted in either a Fatal or B injury during the study period. Installing a roundabout would reduce the likelihood of these serious injury crashes from occurring.

### Suggestion 5: Offset Right-turn Lane

In the interim, a low cost countermeasure that could potentially reduce crashes is the implementation of an offset right-turn lane<sup>4</sup>. An offset right-turn lane, would improve the sightline between drivers stopped on the southbound approach and westbound vehicles that would otherwise be blocked by a right turning vehicle. This implementation could reduce the likelihood of severe angle collisions occurring.

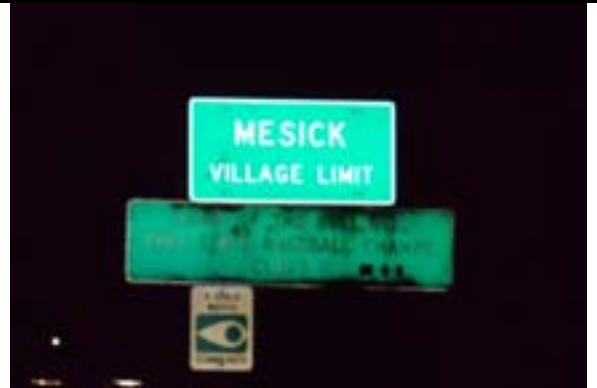
Signs provide guidance to drivers concerning the non-essential roadway. During site visits, the RSA team observed signs that were worn or beyond its useful life, limiting retroreflectivity and conspicuity, and in some cases becoming illegible, particularly during night-time hours. Signs in poor condition limit guidance and may result in sudden braking and erratic maneuvers for unfamiliar drivers.

**Expected Crash Types:** Sideswipe, lost control, rear-end

**Expected Frequency:** Occasional

**Expected Severity:** Moderate

**Risk Rating:** C

## **Suggestion 2: Upgrade Signing**

To improve night-time conspicuousness and visibility, replace signs that are beyond their useful life. The minimum retroreflective standard stated in the MUTCD<sup>3</sup> is that regulatory, warning, and guide signs shall be retroreflective or illuminated to show the same shape and similar color by both day and night. Refer to Section 2A.07 and 2A.08 in the MUTCD for more information on maintaining minimum retroreflectivity.

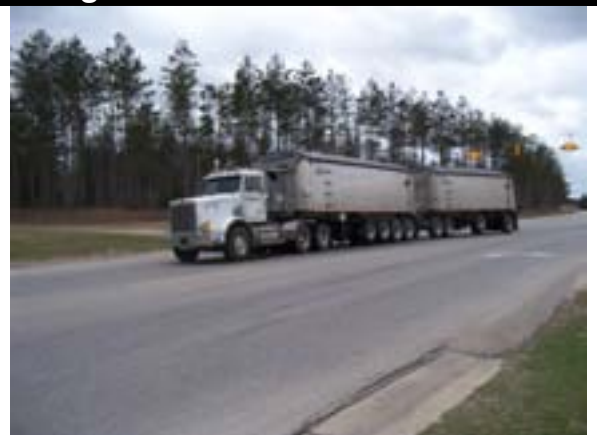
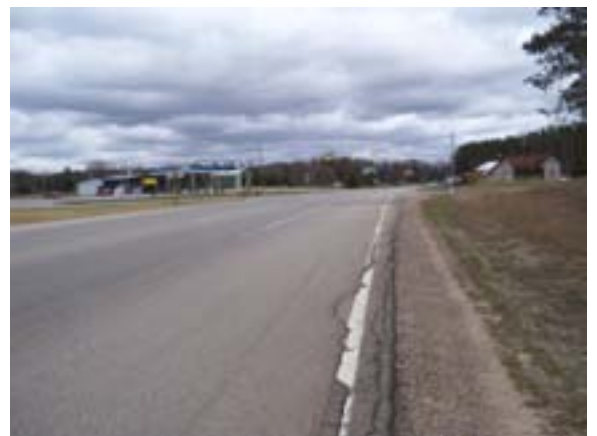
Designated turn lanes are provided on the eastbound, westbound and southbound approaches to the intersection. For drivers approaching the intersection at a high speed (55 mph), the designated turn lanes may not be apparent due to the lack of lane use signs and deteriorated or missing pavement markings. Lane use pavement markings exist for the southbound left-turn lane and the westbound right-turn lane. The designated eastbound right-turn lane is unmarked. The absence of pavement markings may make it difficult for drivers to determine the lane use. The lack of lane use signs and deteriorated or missing pavement markings may contribute to lane changing close to the intersection and an increase in sideswipe collisions. Three sideswipe collisions occurred at or near the intersection during the three year study period.

**Expected Crash Types:** Sideswipe

**Expected Frequency:** Occasional

**Expected Severity:** Low

**Risk Rating:** B

### Suggestion 3: Improve Pavement Markings

Restriping the roadway to provide new pavement markings would help reduce the risk of sideswipe crashes and reduce the likelihood of drivers veering from the travel way. In addition to new pavement markings, designated turn lanes should be marked with designated lane use pavement markings to inform drivers of the correct lane maneuver.

Consider using durable pavement markings, with the installation of a roundabout. Durable pavement markings have a longer service life, and have increased retroreflectivity during night-time hours. These pavement markings would also provide adequate guidance through the roundabout for more years, compared to painted pavement markings.

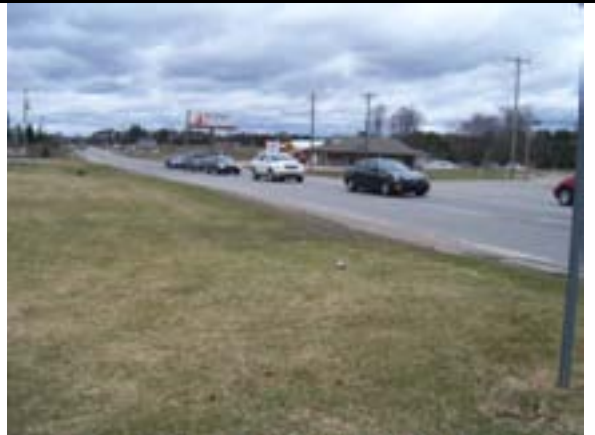
The intersection experiences congestion in the southbound left-turn lane during peak hour times. The congestion contributes to long queues, which increases delay, and may result in rear-end collisions due to unexpected stopping.

**Expected Crash Types:** Rear-end  
**Expected Frequency:** Occasional  
**Expected Severity:** Low  
**Risk Rating:** B

The installation of a roundabout would also reduce delay and queuing that occurs in the southbound left-turn lane. Drivers would no longer risk choosing inadequate gaps due to frustration because of long delays. Additionally, southbound rear-end collisions may be reduced when seasonal excessive queuing is reduced.

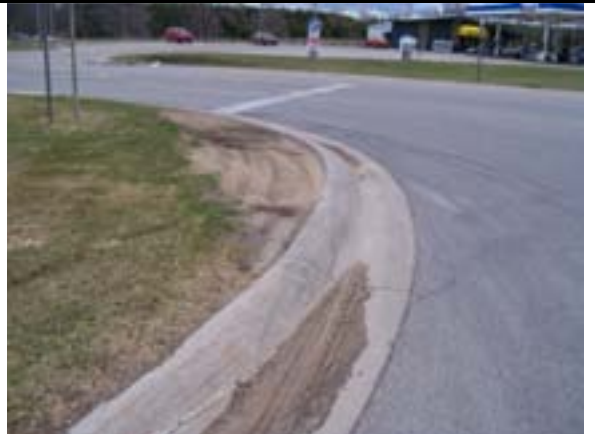
Tire tracks on the northwest corner are evidence vehicles having difficulty making a southbound right turn. The tight turn radius requires vehicles, most likely large trucks, to mount the curb when making a southbound right turn. Therefore, the turning radius may not be large enough to comfortably accommodate large vehicles. This may result in a driver losing control of their vehicle while trying to track back onto the roadway.

**Expected Crash Types:** Run-off-road  
**Expected Frequency:** Infrequent  
**Expected Severity:** Low  
**Risk Rating:** A

### Suggestion 4: Re-evaluate Turning Radius

Re-evaluate the existing turning radius to determine whether a larger turning radius is needed for the proposed roundabout. An adequate turning radius would comfortably accommodate large vehicles turning right from the southbound direction.

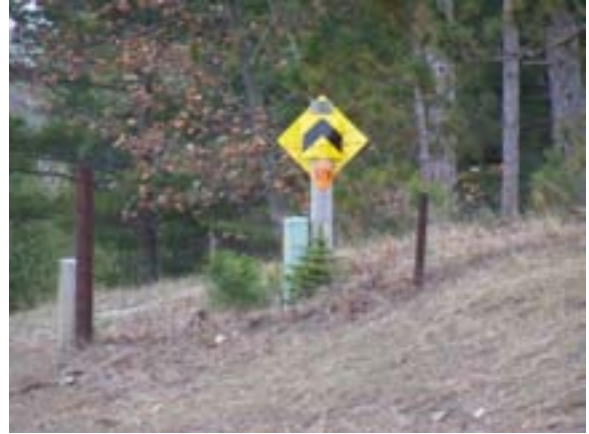
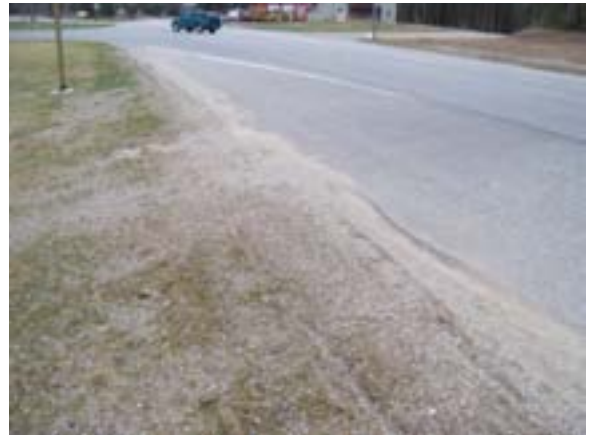
A snowmobile trail exists near the intersection and crosses across M-115 to the west of the intersection. The trail attracts heavy volumes of snowmobile road users and design requirements are needed to accommodate these road users.

During the site visits, pavement and shoulder deterioration was observed, where snowmobiles cross the roadway.

**Expected Crash Types:** Snowmobile Related  
**Expected Frequency:** Rare  
**Expected Severity:** Extreme  
**Risk Rating:** C

The installation of the roundabout should also accommodate snowmobile road users due to the trail that crosses west of the intersection. The proposed design should consider moving the crossing away from the proposed roundabout location to reduce driver workload at the roundabout. The snowmobile crossing should also be accommodated with concrete pavement to reduce surface deterioration. Adequate facilities for snowmobile road users with proper width and design would reduce the potential for damage and increase service life of the transportation facilities.

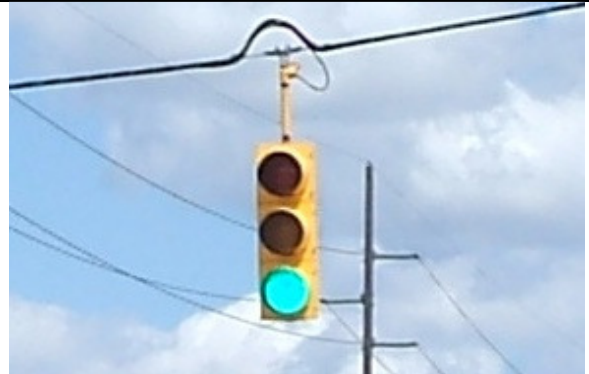
A signal warrant has been performed by MDOT, and the results determined that the signal installation is not warranted. There is high risk involved with the installation of a signal at this intersection, due to the long stretch of unsignalized intersections on M-115. Drivers on M-115 would likely disregard the traffic signal and result in severe high speed crashes. Therefore, it was determined that a signal should not be installed at this intersection.

**Expected Crash Types:** All  
**Expected Frequency:** Frequent  
**Expected Severity:** High  
**Risk Rating:** E

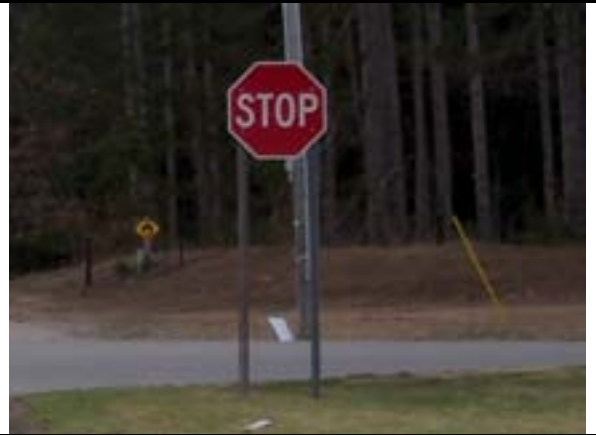
During the RSA preliminary findings meeting, an all-way stop control design was suggested. After consideration of the all-way stop control, the RSA team has determined that an all-way stop control on M-115 would have similar risks as a signal control. Drivers would not expect to have to stop on M-115 and this may result in an increase of serious injury crashes.

A multi-way stop study was conducted and it was determined that a multi-way stop is not warranted due to crash experience. Therefore, it was determined that an all-way stop control should not be implemented at this intersection.

**Expected Crash Types:** All  
**Expected Frequency:** Frequent  
**Expected Severity:** High  
**Risk Rating:** E

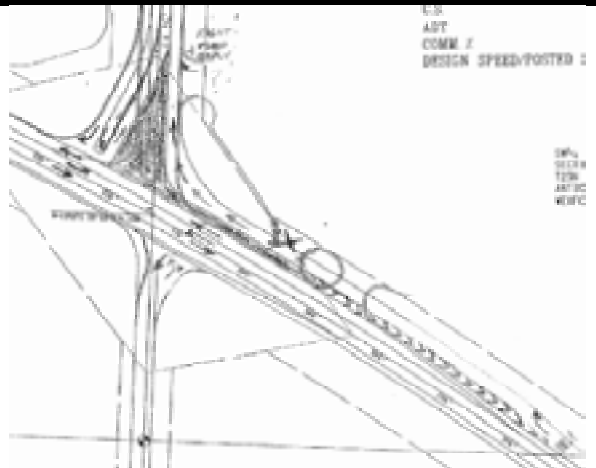
Realigning the intersection, as shown in the preliminary design provided by MDOT, would increase conflict points at the intersection. Although the design would improve the westbound right-turn movement, and conflicts associated with that movement, the offset of the north and south leg, would still result in crashes occurring at the intersection.

**Expected Crash Types:** All  
**Expected Frequency:** Frequent  
**Expected Severity:** High  
**Risk Rating:** E
